1999 28' single diesel pilothouse fisherman

* The following is the list of Deficiencies, (not listed in priority order), that require correction.

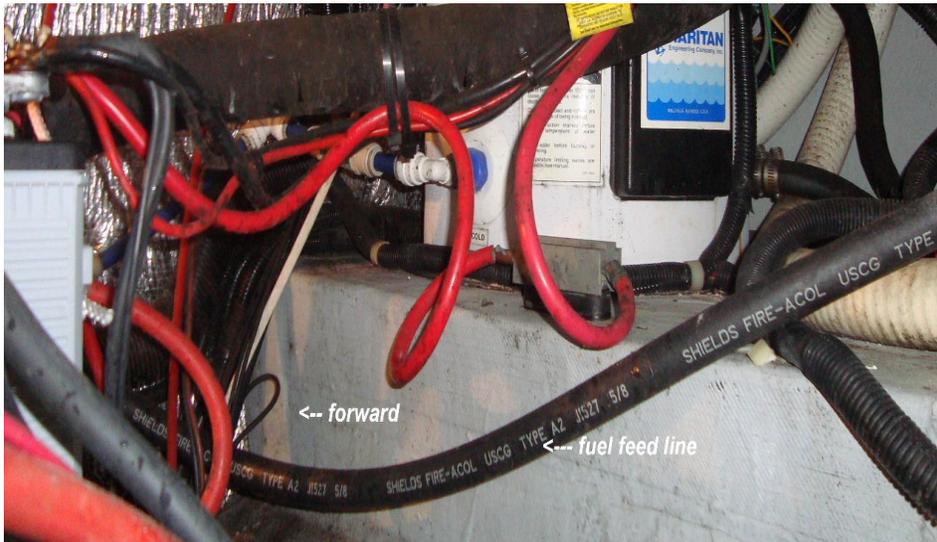
2-- fuel feed line (appeared from fwd. tank) runs fwd.- aft stbd. & outboard of the engine; needs to be supported, at height above the tank and protected from chafe. *ABYC std H-33.7.1 Hoses shall be secured and routed so that they will not chafe on boat structure or equipment.. 33.7.2 Clips, straps or other means used for securing fuel lines shall be of corrosion resistant materials, & 33.7.2.1 shall be designed to eliminate cutting or abrading action where in contact with the fuel line. 33.14.4.2 Fuel lines between the tank and valve shall be secured above the top of the tank with clips or straps capable of withstanding a 2 1/2 minute fire test.*

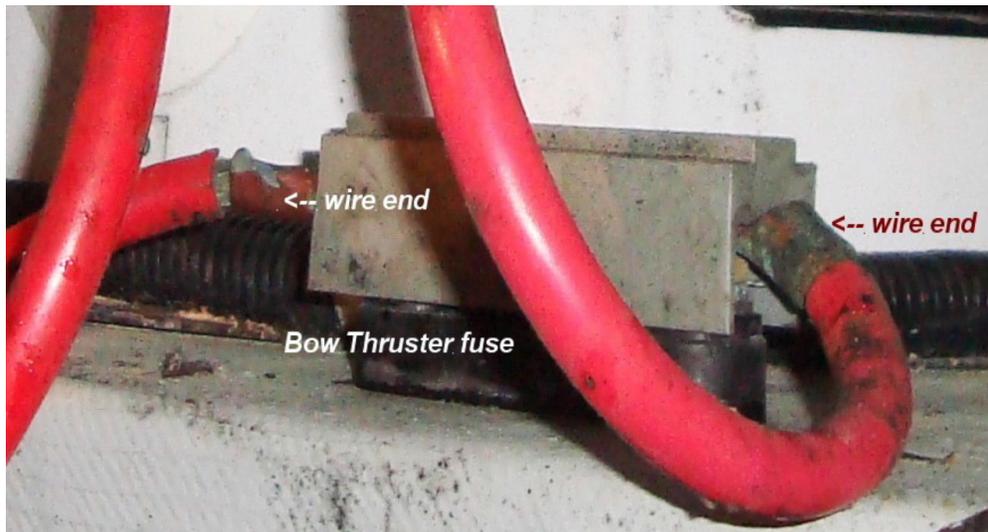
C) wire runs stbd. under the cockpit need to be neatly bundled & harnessed / supported.
