VESSEL: 2005 35' gasoline engine Motor Yacht

* The following is the list of Deficiencies, (not listed in priority order), that require correction.

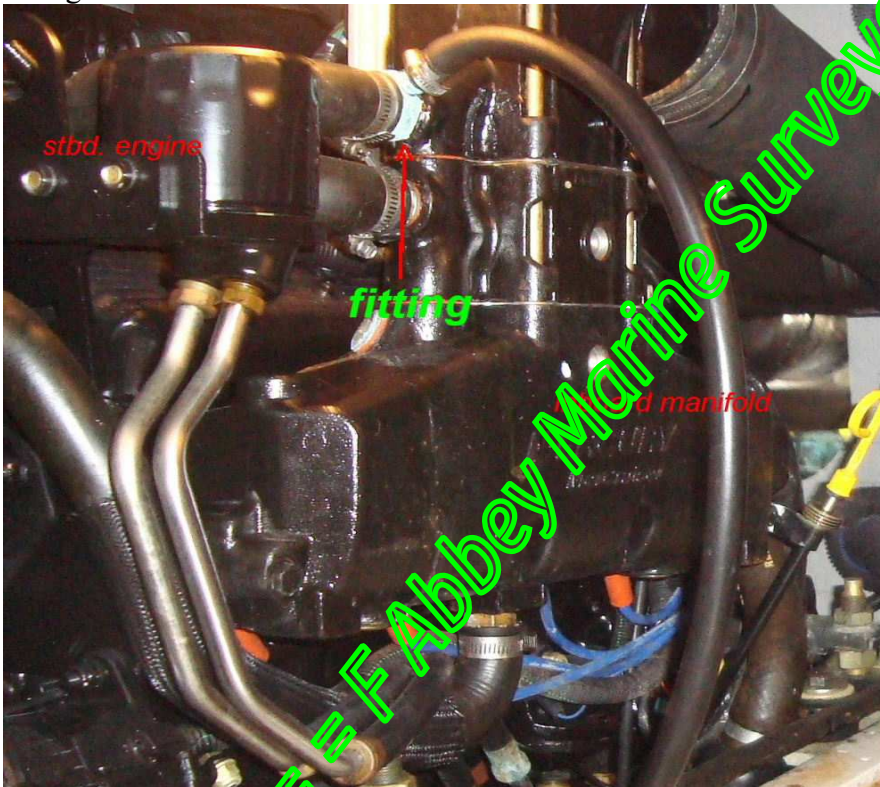
4-- "T" fitting w/ 2- hose connections (one serves raw water flow for prop shaft log's raw water injection) on stbd. engine's inboard riser shows white / green corrosion / sea water leak(?) stains. Remove & inspect fitting & hose for leaks / deterioration.

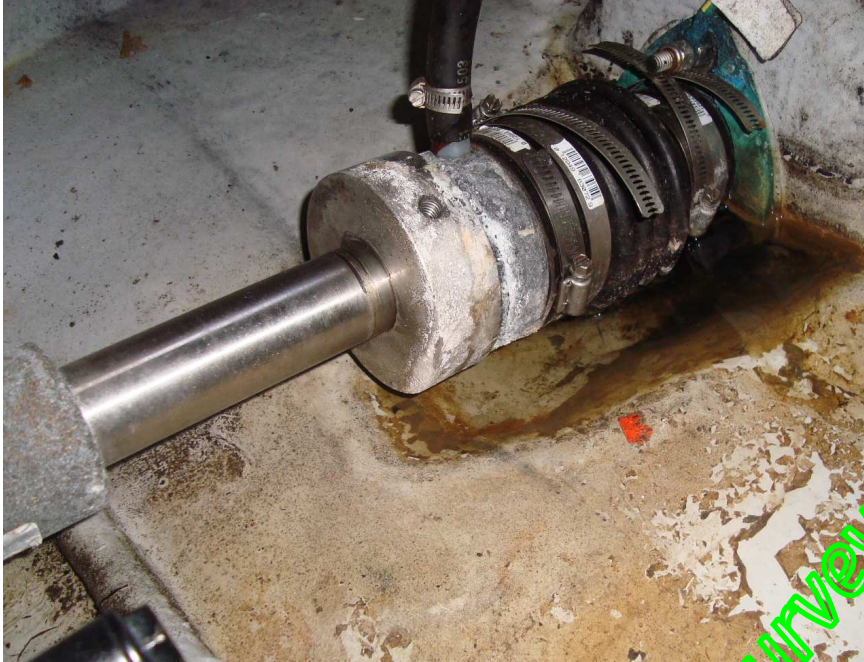
5-- stbd. propeller dripless stuffing box (by PSS) ss. rotor shows salt deposits & pitting (from previous sea water leak?). Inspect and verify assemblies condition; service as needed.

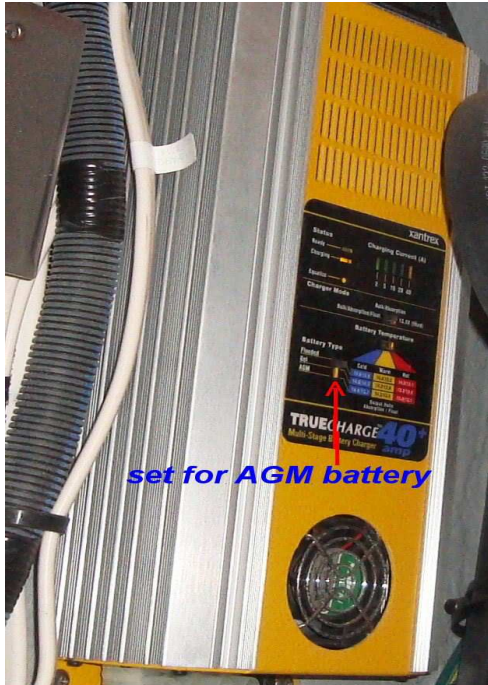
C) a review of various guides regarding marine battery types and installations indicates that it is not recommend to mix battery types as the have different discharge rates and re-charging requirements and that AGM batteries are heat sensitive and should not be installed in the engine space. (see Note I & ii)

D) Only one battery charger (Xntrex True Charge 40+) was sighted installed in this vessel and its on unit LED status indicator showed charger out-put is set for AGM batteries (yet the vessel is rigged with 6 lead-acid batteries. (see photo p 3)
