VESSEL: 198x 33' sloop rigged sailboat

* Partial survey xx-xx-2016; vessel blocked on-shore. The following is the list of Deficiencies, (not listed in priority order), that require correction.

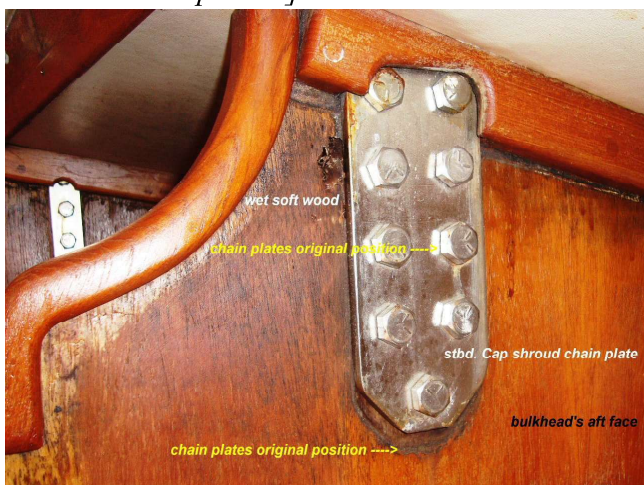
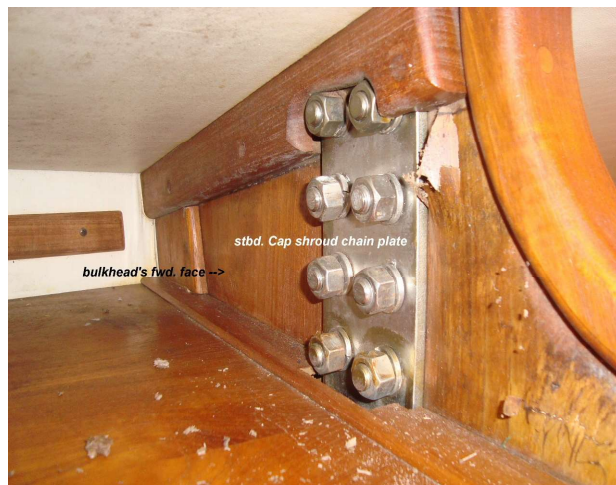
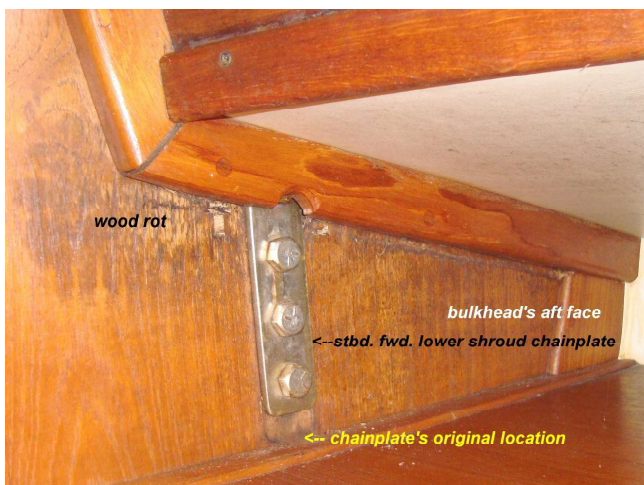
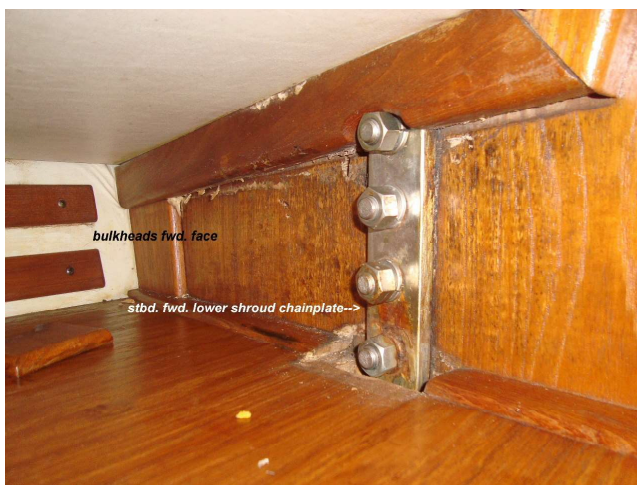
1-- standing rigging chain-plate attachment failure at **stbd. cap shrouds & fwd. lower shroud.**

(chain plates (for port & stbd. cap and fwd. shrouds) are flat ss. plates; that pass through the deck and; are through bolted too separate teak over plywood bulkheads (which are tabbed onto the hullsides).

A) The two separate bulkheads (teak over plywood) that the stbd. cap & fwd. lower shroud's chain plates are secured too show wet - rotted - deteriorated (a blunt probe was easily pushed completely through the wet rotted wood) apparently due to water leaking in at the improperly bedded chain plates; and being trapped / retained between the ss. plate & its wood bulkhead),

B) these two shrouds are slack as; each chain plate has been displaced / pulled up apx. 3/8", from their original position: Rigging loads apparently have caused the chain plate to bulkhead throughbolts to be displaced / pulled upward; as the wet / rotted wood could not support the strain imposed by the standing rigging. [Note: Situation comprises the standing rigging's integrity. Bulkhead structures need to be replaced, or possibly rebuilt with "sistered" in wood / other structures: Consult with rigging specialist and marine carpenter.]

1- C) the companion port-side chain plates need to be un-bolted removed from their bulkhead to

determine if there is any moisture & or deterioration behind them.

D) each chain plate should be inspected for crevice corrosion serviced as needed and polished / cleaned prior to installation & bedding.

Vessel should not be placed in service until chain-plate / bulkhead defects are resolved.

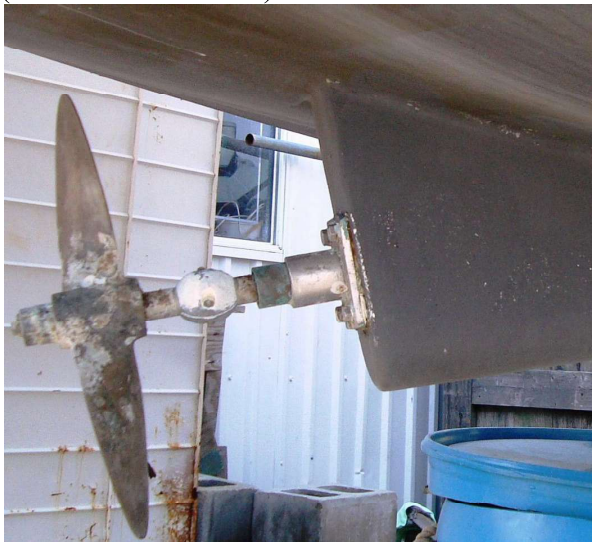
5-- propeller shaft ss. 1” dia.

A) cutlass bearing (in bronze on skeg fitting): shows worn / excessive (> 1/8”) play.

B) propeller shaft needs to be removed & inspected for wear / deterioration (from running with a worn - cutlass bearing); past experience shows that it is probable that the shaft will need to be replaced.

C) engine mounts (show rusted) need to be inspected w/ engine running underway (prior to cutlass bearing replacement) to determine if they require replacement.

E) shows black burn(?) marks section just fwd. of the stuffing box.

F) has excessive unsupported overhang; total of 9 1/2” cutlass bearing exit to shaft end and; apx. 4 1/2” cutlass bearing exit to propeller hub fwd. edge. (engineering accepted overhang dimensions are as follows: “Propeller Overhang: The distance between the forward end of the propeller hub and the aft end of the last strut bearing shall be limited to one shaft diameter. This does not apply where the last bearing is installed aft of the propeller.” Pacific Marine & Industrial Division of Quality Pacific Manufacturing, Inc. Richmond, California) (Also see Note# 4 & 6)

D) propeller shaft / engine (post installation of serviced / new components) need to be carefully aligned.

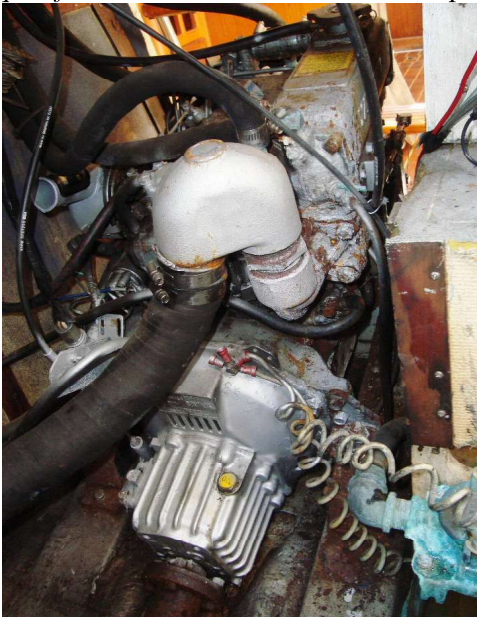
8-- engine (Yanmar freshwater cooled diesel):

A) crankcase lube oil shows thick & black colored (appears as not changed prior to vessel lay-up).

B) cooling system hoses show stiff / old.

C) fresh water side of heat exchanger (accessed @ pressure cap) appeared “dry” no anti-freeze fresh water evident; inner surfaces @ pressure cap showed rust residue.

D) engine mounts show rusted.

E) external surfaces of heat exchanger / exhaust manifold & cast iron exhaust riser elbow show rust stains.

*Note: Service history and time when last in use are unknown (see *NOTE# 1): Engine (under observation) needs to be run w/ vessel under way to help determine its operational status / condition and needs to be inspected by a qualified mechanic to determine the repairs / service required to have engine in proper operating condition.*

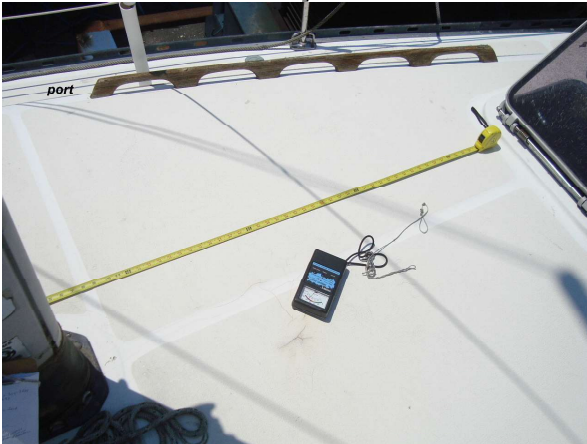
11-- cabin top deck area fwd. of the mast pass-through too the aluminum framed hatch (sized apx. 50"-54" L x 46" - 54"W) between teak grab rails:

A) shows highly elevated moisture readings (meter @ 60-95) indication moisture intrusion into the core.

B) shows through gel coat cracks (cause undetermined) area sized apx. 12" x 12" which as percussion

sounded produced a slight dull-soft sound report. *[Consult with a marine frp. repair technician for additional assessment of the condition and advice regarding remediation / repair.] [Moisture readings via Tramex Skipper Plus meter; set on Range# 1, scale reads 0 - 100, 0 - 25 is the "dry-range". Metered surfaces appeared free of surface condensation & salt residue.]*
