Survey Found Fuel System Deficiency

In conducting a survey, of a 2004 35' twin gasoline engine production express cruiser (built in USA), a fuel system deficiency situation, often not immediately visible or obvious, was discovered.

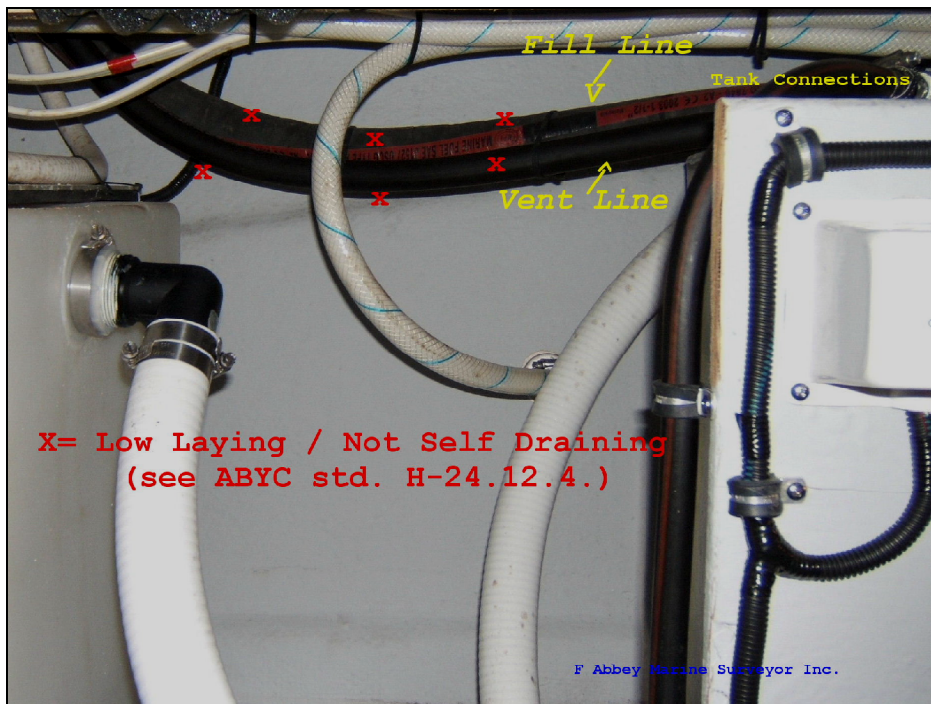
The photograph (of the port fuel tank) shows that the run, of the fill and vent lines rigged to each of the two (installed port & stbd. in the engine space) fuel tanks, are not self-draining. This situation does not comply with the provisions of **A.B.Y.C Standard H-24.12.4** "Fuel fill lines shall be self-draining and run as directly as practicable from the deck plate to the fuel tank connection and **H-24.13.7** "Tank vent systems shall be self-draining".
