Survey Found Gen-Set Engine Exhaust System Deficiency

In conducting a survey, of a 1988 35' single diesel engine powered downeast fisherman equipped with an auxiliary gen-set a installed post original construction; the gen-set engine's exhaust was found to have been improperly rigged.

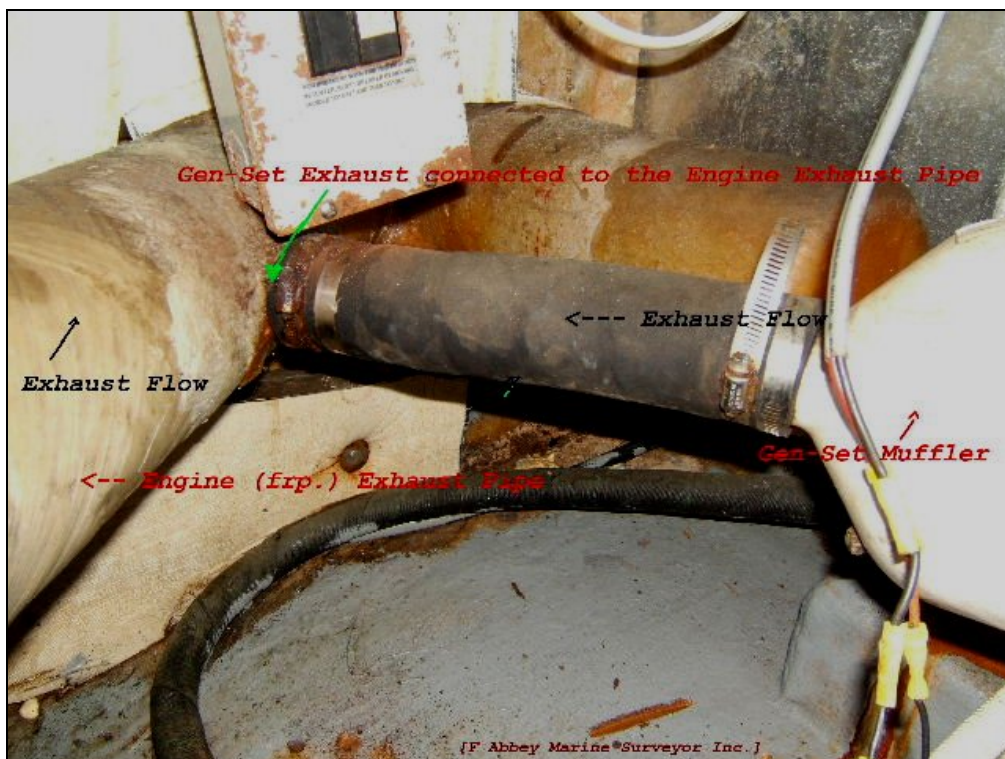
The photograph shows that the gen-set engine's exhaust outlet has been connected via frp. pipe (somehow) attached into the propulsion engine's frp. exhaust pipe. This situation does not comply with the provisions of **A.B.Y.C Standard P-1.5.7**. "A separate exhaust system and terminus shall be provided for each engine and generator installation; and **P-1.5.8**. Exhaust system piping and components shall be supported to minimize the risk of failure from vibration, shock, expansion, and contraction." Additional issues are: A) rusted clamp. B) worn hose. C) metal box (w/ AC breakers) chafing against the frp. exhaust pipe. D) wire runs hanging loose / not-supported..
