Frank Abbey Marine Surveyor & Consultant Inc.

Vessel: 1986 xxxxx 36

SURVEY REVIEW TABLE OF CONTENTS

<u>Reason for Survey, *as requested by client:* survey review (non-testing) as per client's request of: "give us an idea of the boat's suitability for an ocean passage, and what areas need attention, repair, replacement improvement or refit".</u>

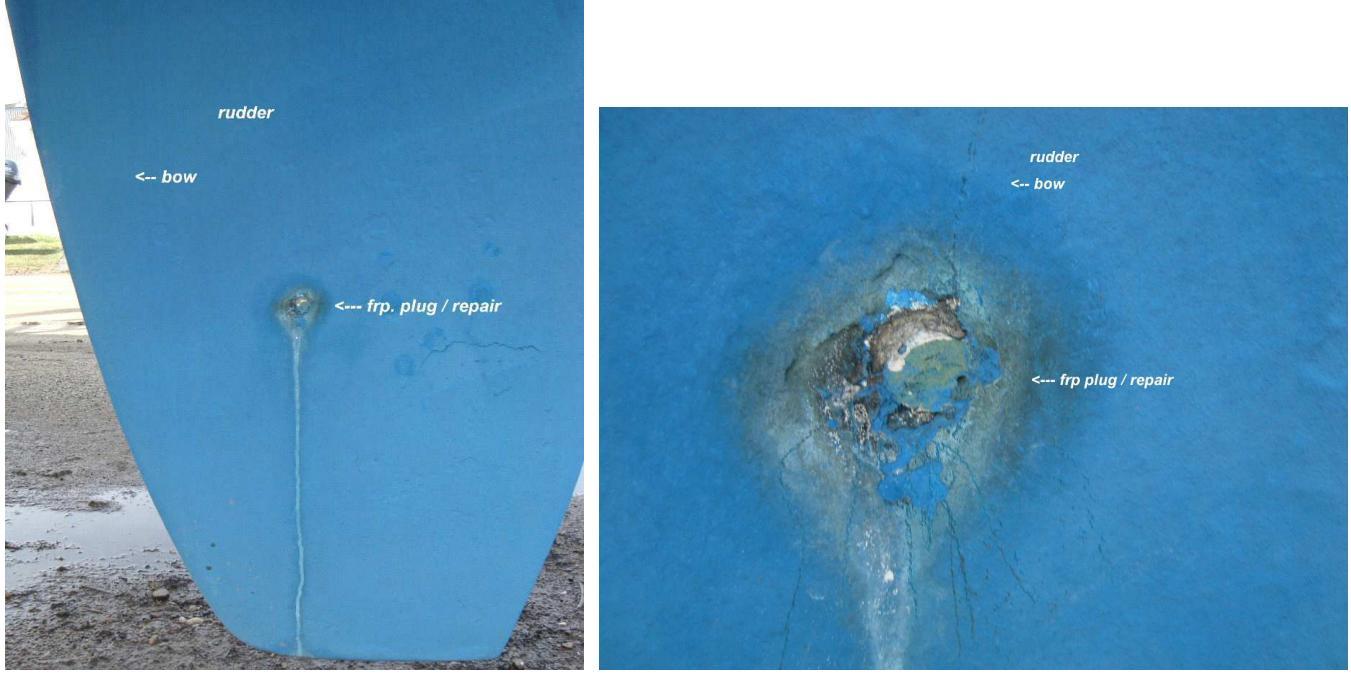
1-- Rudder (frp. free standing spade type; shaft / steering quadrent could not be accessed): A) port surface shows circular frp. repair / plug (sized apx. 1" dia.; located 19" up from rudder's base) and a fluid drip-stain running down to the rudder base. *Remarks: Cause / origin / purpose of observed frp. belmish could not be discerned. Possible that it was a reapair or from draining internal water accumulation.*)

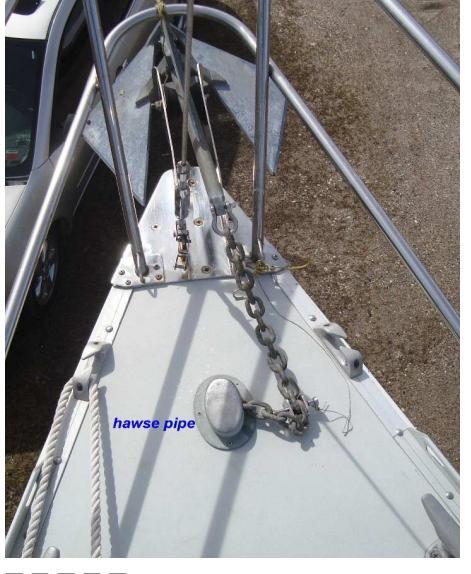
5-- *Anchor needs to be secured at the roller in a manner sufficient for offshore -storm conditions that may be encountered. (*It may be advisable, for offshore passage, to stow the anchor below deck.*)

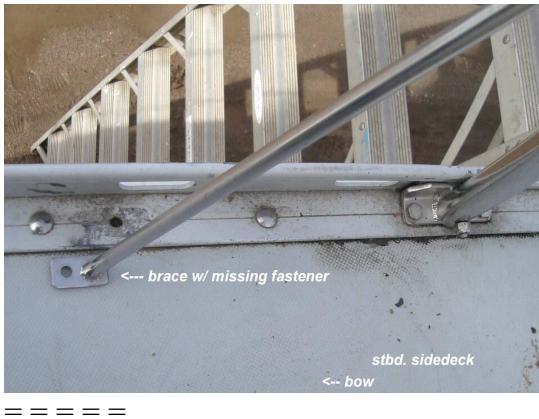
*6-- Life-line Stanchion: stbd. fwd. stanchion (at the entry gate) aft brace's base is adrift / unfastened at the deck / toe-rail.

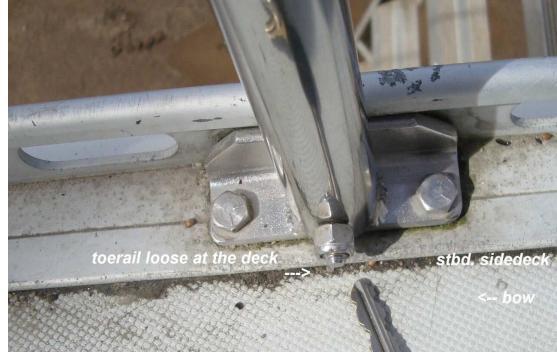
*7-- Toe-rail: A) stbd. sidedeck at the 2- entry gate stanchions. B) port sidedeck at stanchion, 2ed aft of the bow: shows upward movement (apx. 1/8") when an outboard directed load is applied to the stanchion.

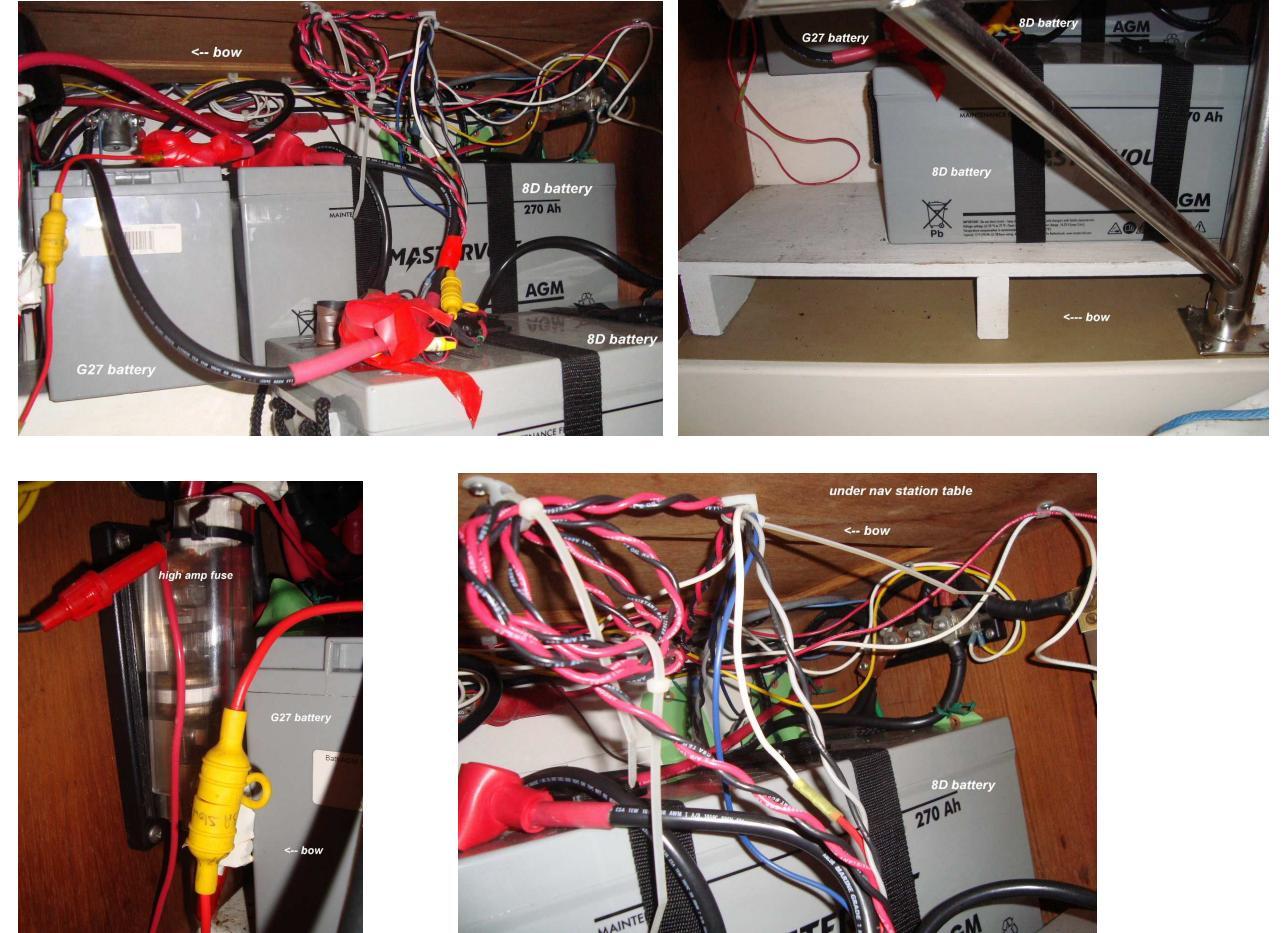
15-- D) DC branch circuit wires coiled / hanging under the nav station table could be more neatly lead. *E) 8D battery on the lower shelf, is set on a wood platform (appeared as secured to the battery via the single nylon strap); the platform's aft end is secured from athwart movement by the nav station seat pedestal while the *fwd. end appeared unsecured; *the platform and battery each needs to be secured in place ; see note 15A*.

*F) a cover needs to be installed on the "+" post on solenoid (installed above G27 battery)

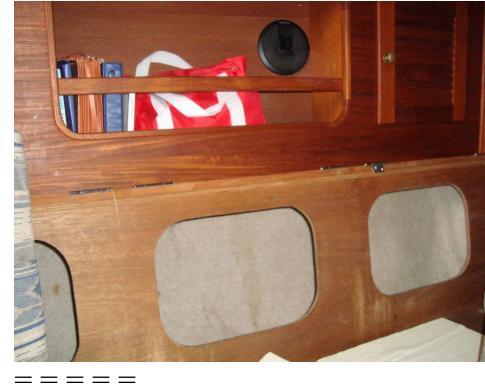
*16-- add net / additional slats, to open sided in cabin storage bins, to secure gear in any sea conditions.

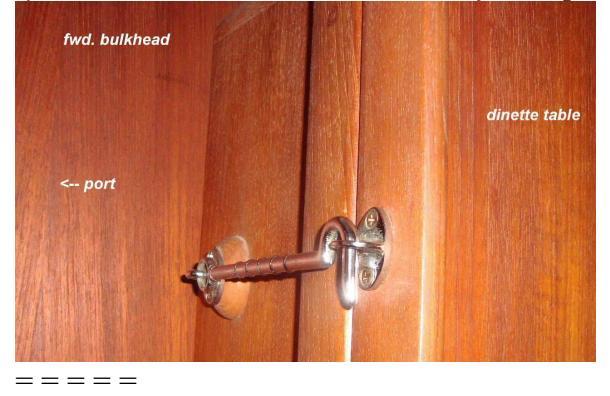
*18-- Dinette Table in folded up position is held in place via a single hook & eye fitting: *Replace hook-eye with a latch that can be secured from opening / giving way when running in rough sea conditions.*

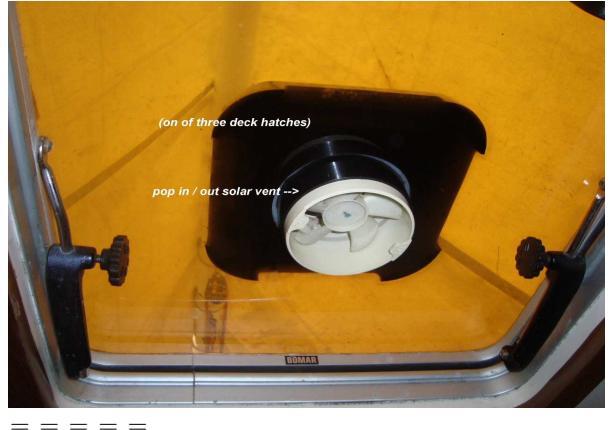
19-- solar powered plastic vents installed (held in place via friction fit vent tube to on hatch fitting) on the 3- Bowmar deck hatches: *Recommend A) rig mechanical means (i.e. quick pin / clevis pin w/ hitch pin) to secure the vent to the on hatch press in fitting. B) Carry an inventory of deck plate insert to use in place of the solar vents when sea conditions make cause the decks to be awash with sea water.*

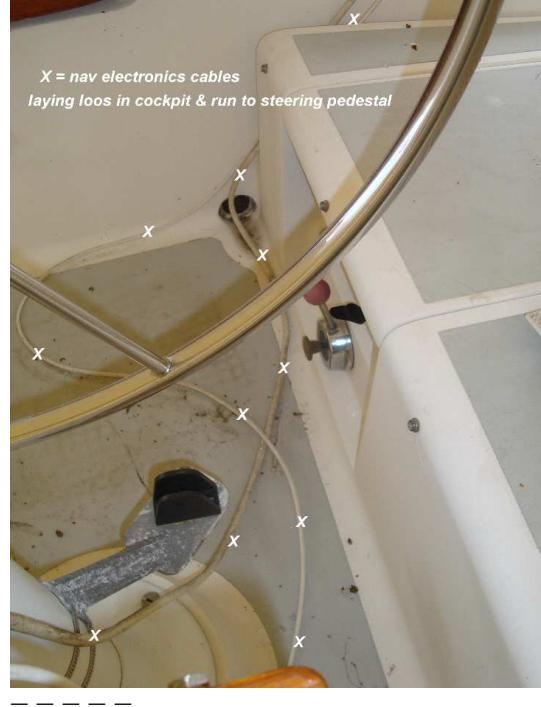
*32-- navigation cables (white insulation); run from antennas (installed on mast aft port in cockpit) to the steering pedestal; *are laying loose / unsecured / in the open (exposed to weather) on the cockpit sole (*also present a trip & fall hazard).*

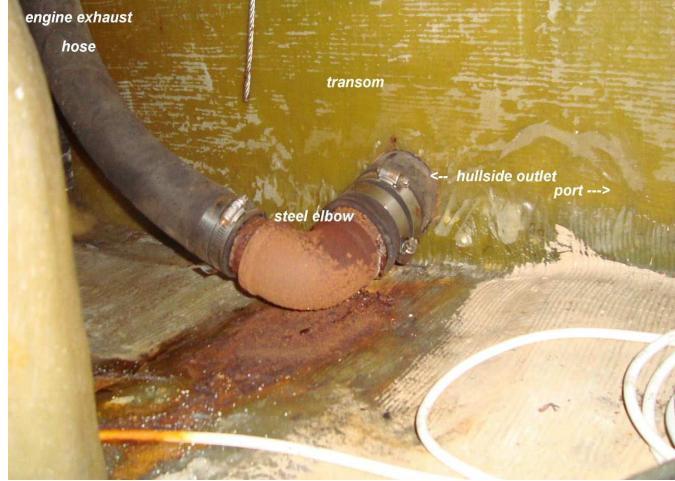
*33-- engine exhaust system: *Steel elbow, at exhaust hose to transom out let, shows heavily rusted external surface; *heavy rust residue on frp. hull surface below the elbow, indicates elbow / hose leak.

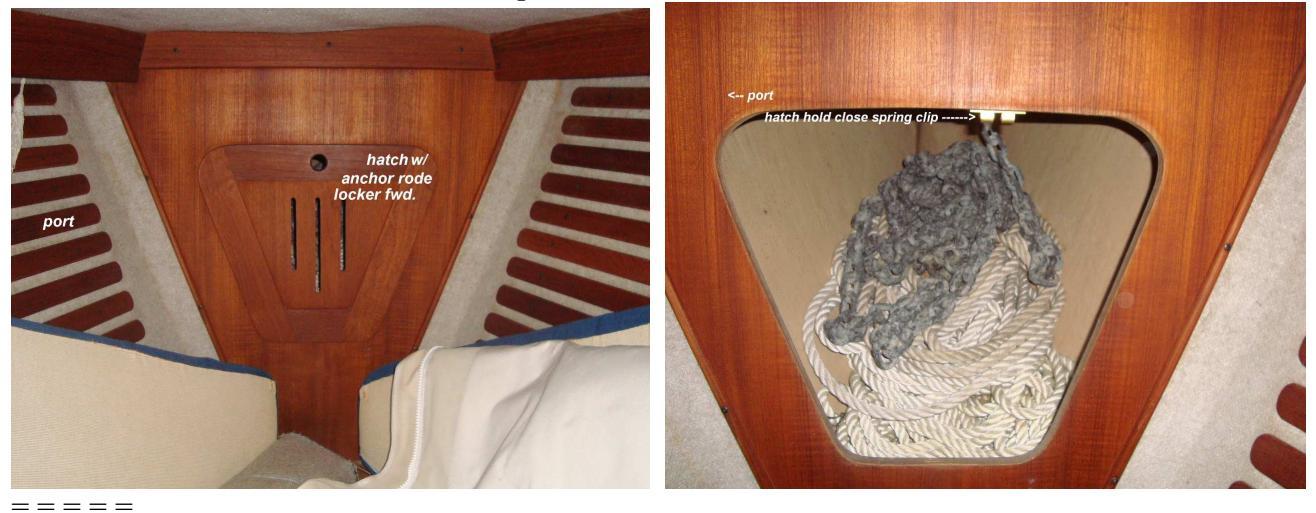
*38-- anchor rode / forepeak locker: A) separated from the V-berth / cabin space by a vented teak panel board secured solely by a spring clip: *Teak panel board needs to be solid and secured in place (to preclude sea water or the anchor road from spilling into the cabin space)*. B) unknown if locker is fitted with a drain. If the locker is fitted with a drain or the drain appears inadequate to rapidly evacuate sea water flooding adequate sized drains need to be installed port & stbd., so that sea water can drain from the locker when the vessel is on a port or stbd. tack.

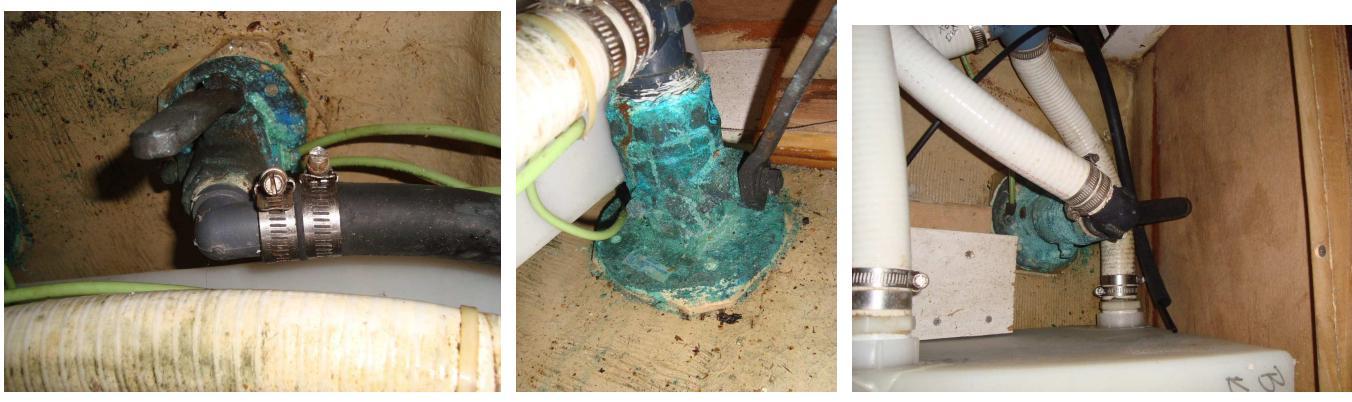
35-- bronze seacocks (in the head & under salon port settee) surfaces show thin white crust residue (possibly the product of stray current corrosion or sea water / MSD fluid leaks). (as accessed, at survey, seacocks appeared operational and sound no deterioration evident.)
